Earth Structures

A Strategy for Sustainable Management

Hampshire
County Council

A Strategy for the Sustainable Management of Earth Structures

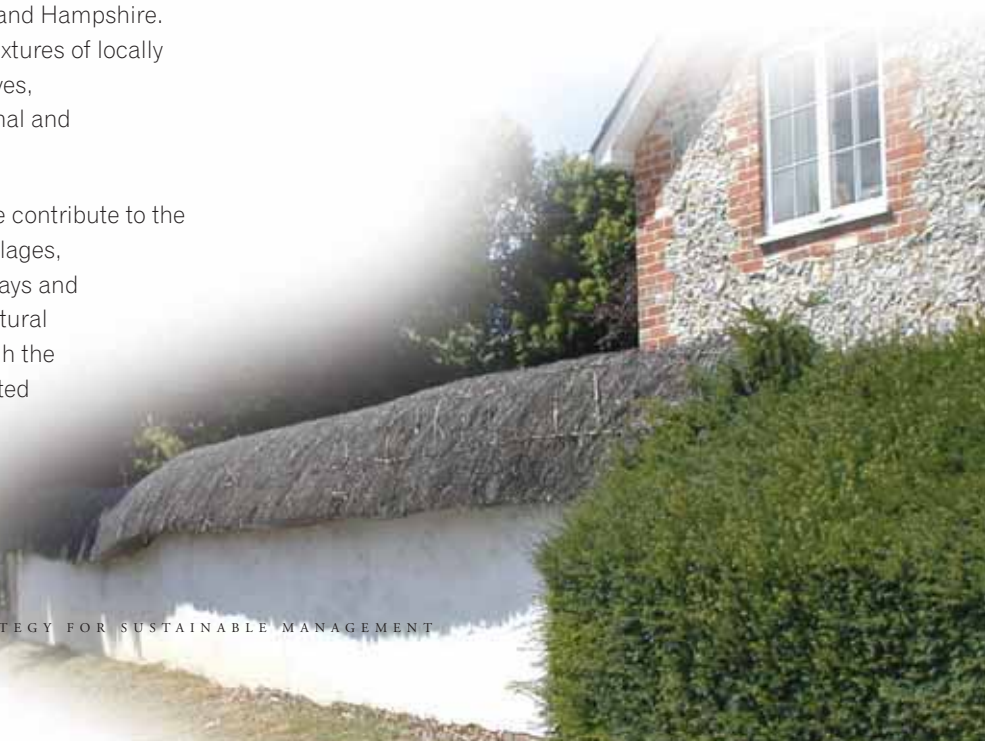
Above: King Somborne, 18th C. cob agricultural building with cob wall boundary continuous with the building line.

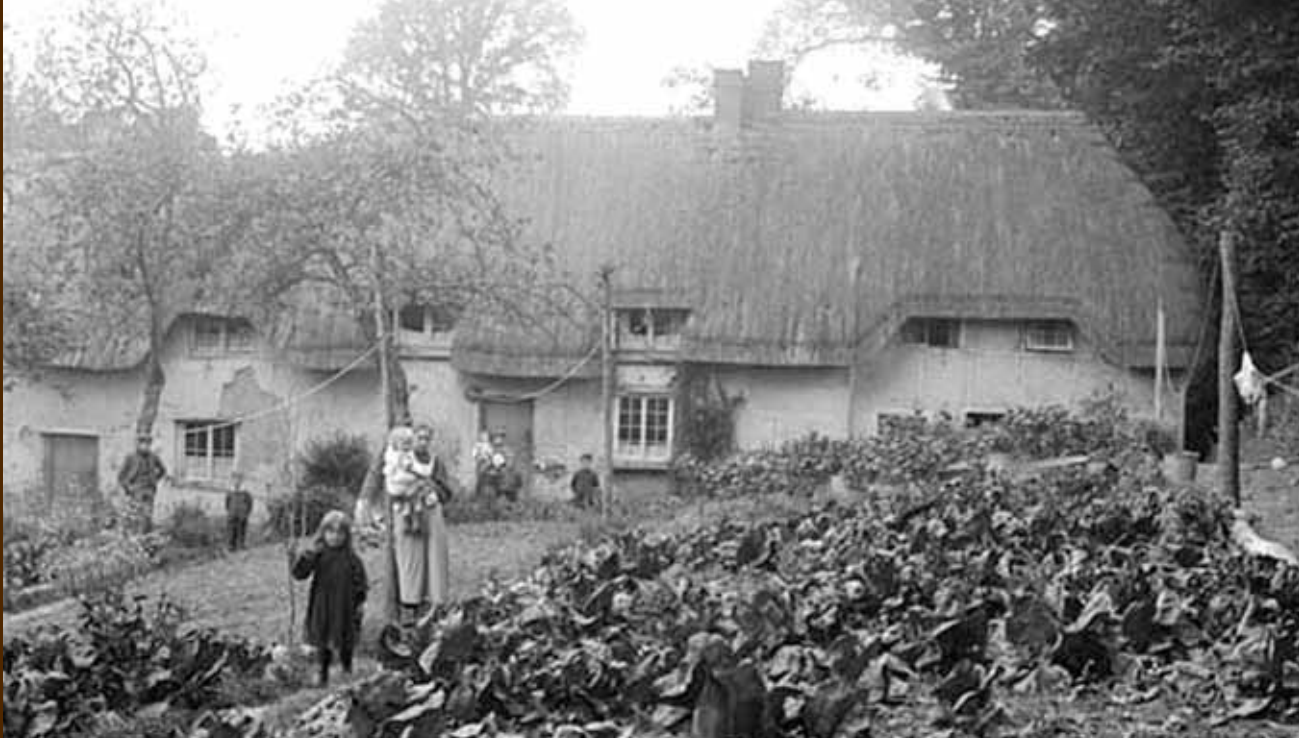
Right: Cob cottage, Outwick, near Fordingbridge. Some render is failing on front of cottage.

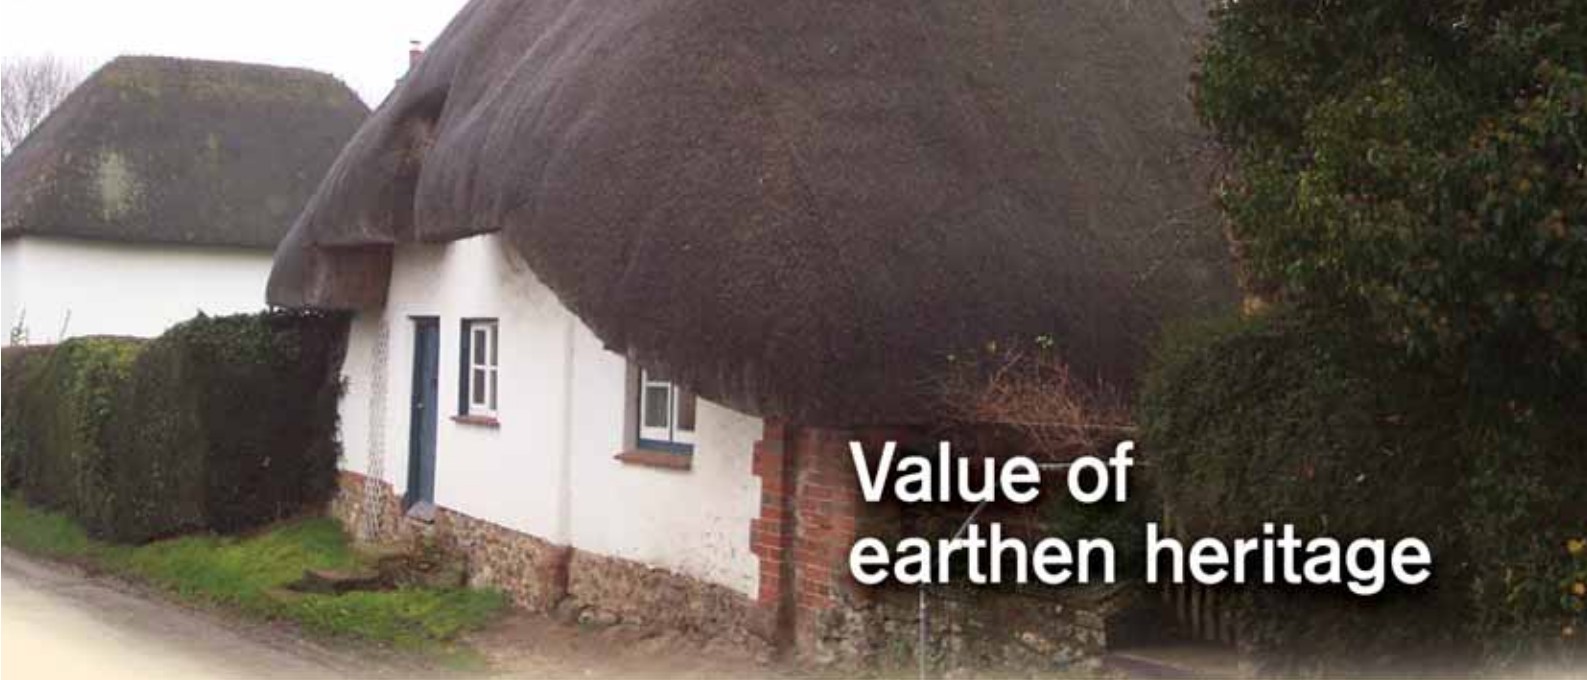
Above: Deep thatch eaves protect the rendered cob walls and flint plinth hence the prescription for cob needing 'a good hat and a good pair of boots'. Longstock, Test Valley.

Cob structures are often associated with thatch roofing. A common Devonian expression was that cob needed “a good hat and a good pair of boots” to protect it. Full gables in cob are unusual as they are structurally weak. Upper floors are usually set within attics and have small dormer windows.

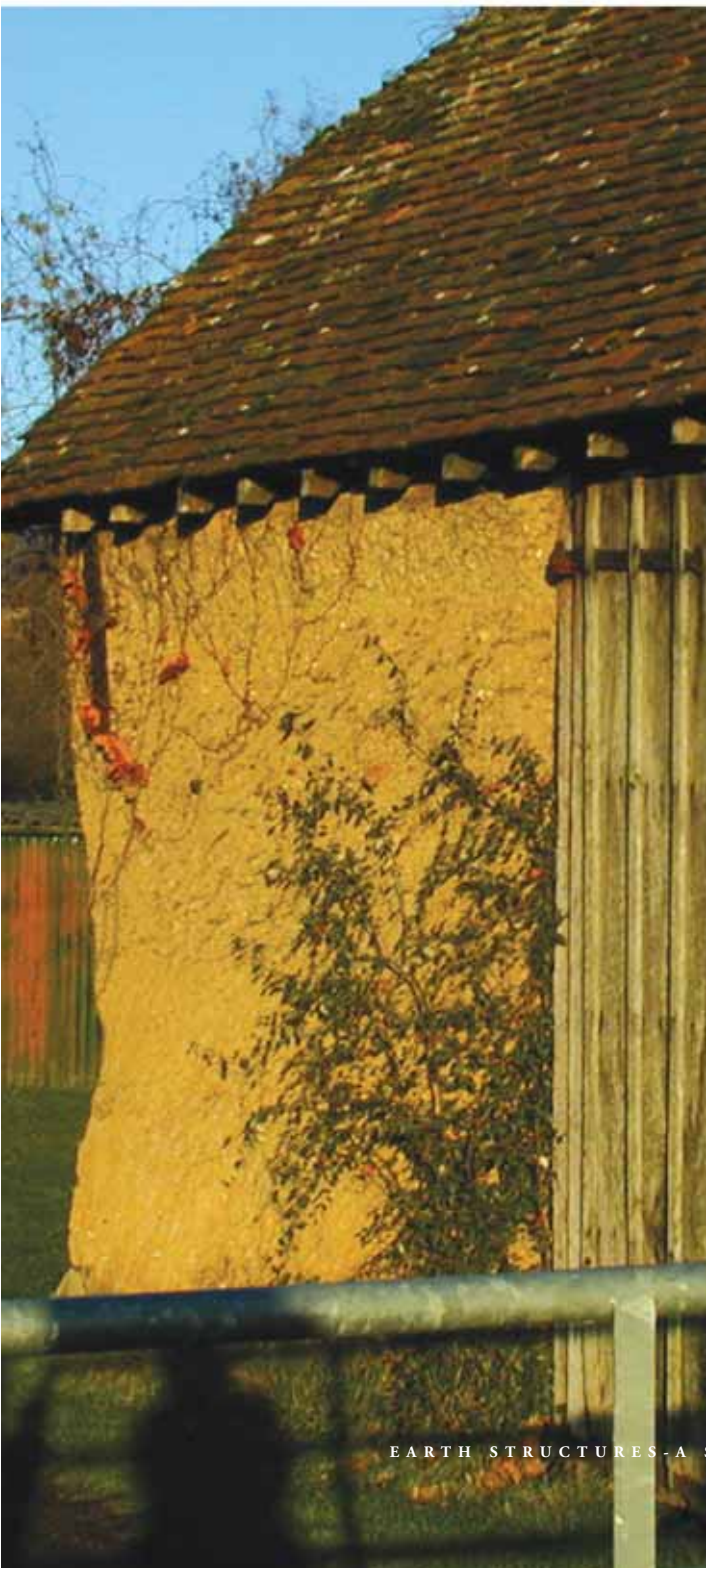
Left: New Forest cob outbuilding showing its true golden colour derived from local clays. Normally this material would be protected under a thin lime render or wash.

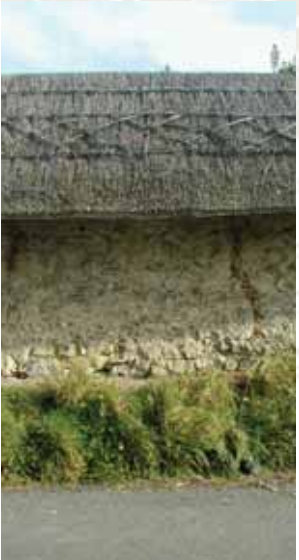
Above:
A well protected chalk cob boundary wall under a deep thatch with old cracks, nicely stitched together with recycled bricks.

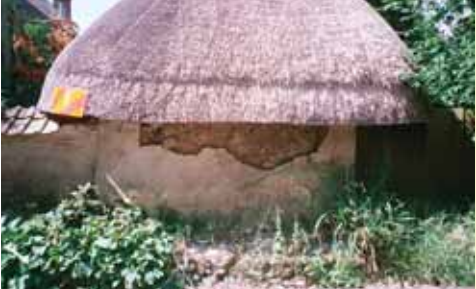
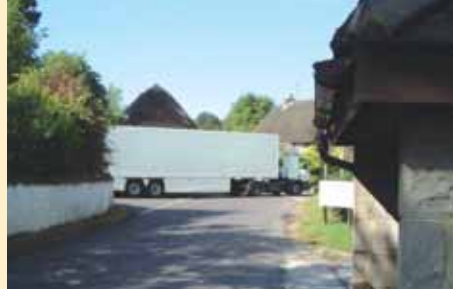
Right: Heavy traffic on village roads can cause physical damage and cracking from vibrations to cob walls, (Monxton Traffic Group)

Left: This attractive outbuilding is protected by the deep thatch eaves, though it is vulnerable from traffic impacts, Monxton.

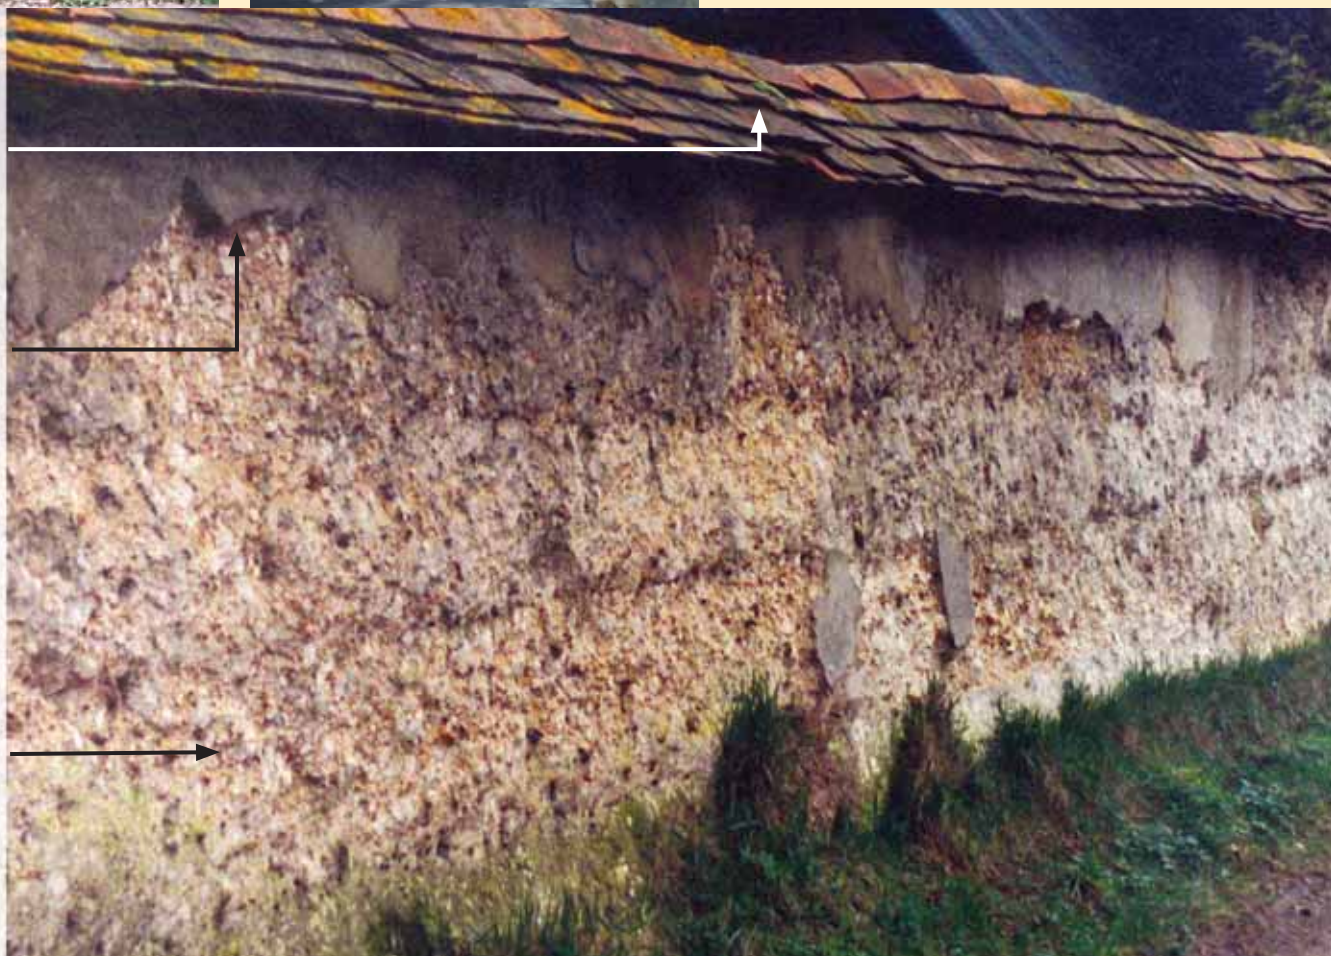
Roadside cob wall approaching crisis due to neglect.

Breakdown of wall-head protection permitting saturation of cob below.

Decay of cob behind water - retaining cement - based render (now largely failing)

Base of wall decaying due to soil build up covering plinth and splash back from passing vehicles.

Keeping water from damaging earth walls is one of the key conservation issues relating to cob structures. Wall tops and roofs must be kept watertight, with a sufficiently deep overhang to prevent water penetrating the tops and upper areas of walls. Wide eave overhangs designed to keep water off the walls should not be altered. Masonry plinths at the base of walls must be kept free of soils banked around them and invasive vegetation like ivy which can prevent them drying out. The ground at the base of cob walls can undermine the structure if it is laid with hard materials that cause splashback onto the lower zones of the wall which take maximum loads. Road traffic can splash water onto untreated cob walls adjacent to the roadside and this can lead to erosion of lower walls. Vibrations caused by heavy traffic and goods vehicles, such as farm vehicles in rural areas, can also be a major cause of cracking in cob structures adjacent to main roads.

The neglect and/or poor repair of cob boundary walls can very easily cause a sudden collapse if a sharp frost follows a particularly wet period in which a wall has become saturated. The use of cement-based renders, paints and other non-permeable finishes that trap moisture in the core of walls can exacerbate a problem in excessively damp walls and lead to render and structural failures. A series of cob-wall collapses was recorded in the Test Valley district during the particularly wet winter of 2001.
