The Conservation of

Water Meadows

Structures

Hampshire
County Council

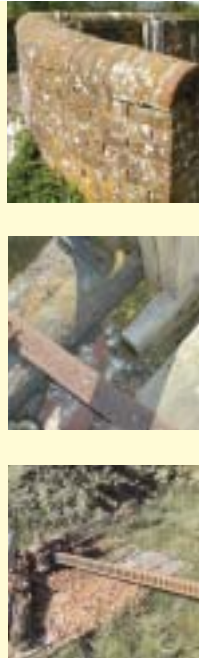
The sluice was used to direct the river from its natural course. In early structures, timber boards were placed by hand into slotted channels in stone or brickwork to control the flow of water. Normally termed 'hatches' these can vary in size from 7, across a main river to a small single 'bunny' hatch, the size of a spade.

In later structures these boards were raised or lowered mechanically using a variety of iron and timber devices often using a rack and pinion system derived from watermill technology.

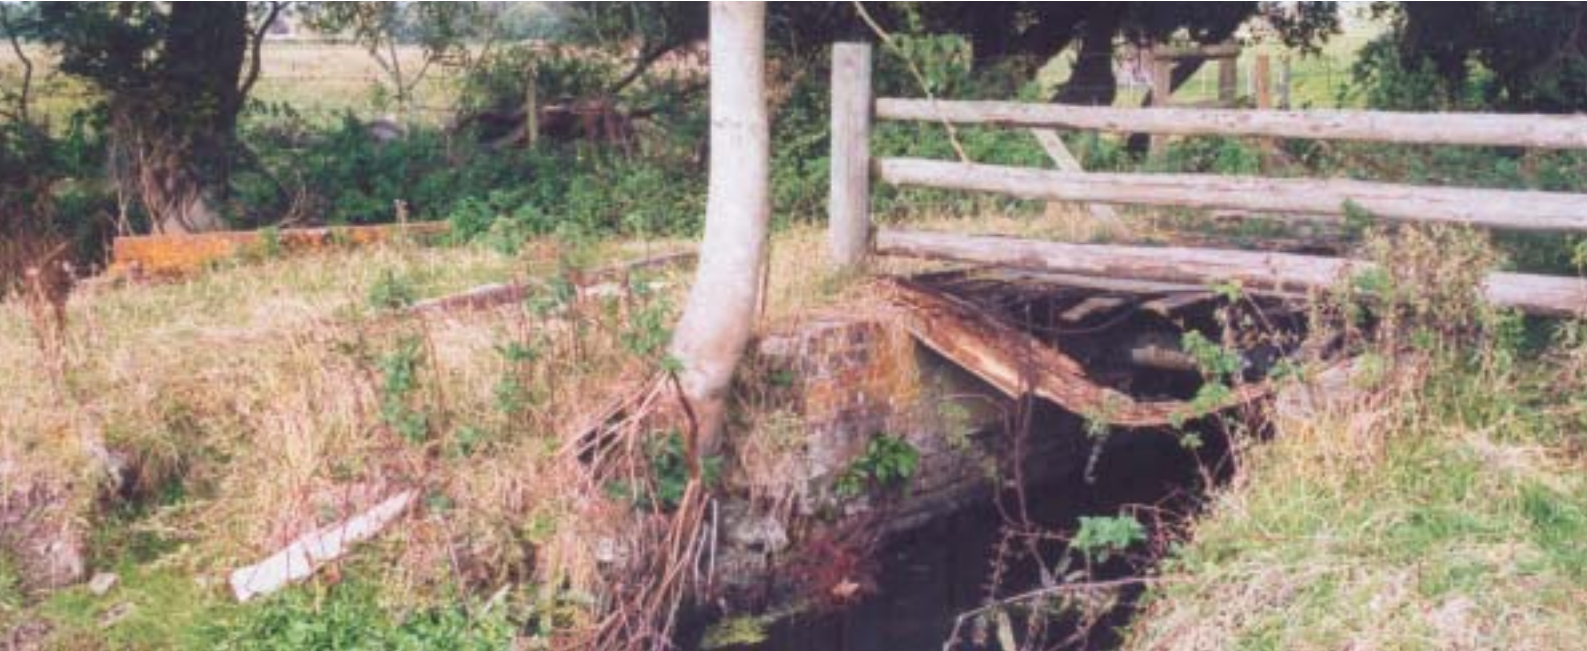
- The river is damned by the **sluice** or hatch or weir and diverted into the **carrier**.
- A **hatch** is opened to let water into the carrier. The hatch is closed when the carrier is not in use to prevent the system from silting up.

- Water from the carrier is let into the water meadow by a subsidiary hatch and is held up by the **stop** and overflows into each part of the meadow in succession. The carriers run along the top of **ridges**, water flowing down the side of the ridge into the **drain** and back to the river. The aim was to achieve a steady flow at a depth through the root mat and stems of the grass sward no greater than 25mm (1 inch).
- In some cases water was directed over the river via **aqueducts** to supply meadows on the other side of a water course, drain or river.
- On many water meadows **bridges** were constructed to enable easier foot and cart access across channels. These may be simple stone slab 'clapper' bridges or more elaborate brick arched structures on later examples. Even later 20th century concrete structures were also used.

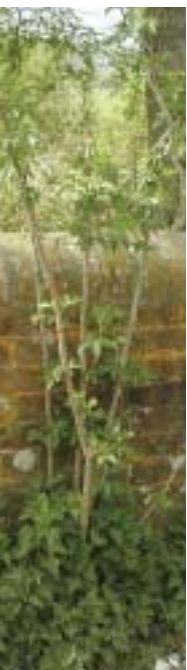
Structures of stone or brick in a damp environment will naturally attract moss and lichen growth, and in some cases grass where there is a thin soil covering. Their presence is not likely to cause damage to the structure and may be important ecologically and should not be removed. It is, however, important where practical to cut back excessive vegetation if there is a danger that a structure may become overgrown and completely obscured. If the water meadows are regularly grazed then this will usually be the most appropriate method of control.

Larger shrubs and tree growth where root systems are causing damage to brick and stone structures have to be dealt with on an individual site basis with relevant ecological and arboricultural advice. In some circumstances the careful removal of a tree which is causing damage to an otherwise sound brick structure will cause little impact to the landscape or ecological quality of the site. Where a structure has reached the point of dereliction requiring extensive rebuilding, the correct approach may be to consolidate the sound existing structure but accept the loss of some part with vegetation retained but controlled to prevent further damage. The water meadow system can still operate with little loss of historic material.

Trees or shrubs should be cut back to as close to the structure as possible and the root system left to decay in situ. Physical removal will usually result in structural damage. In certain circumstances it may be necessary to treat the stump locally with a suitable biocide to accelerate the process.

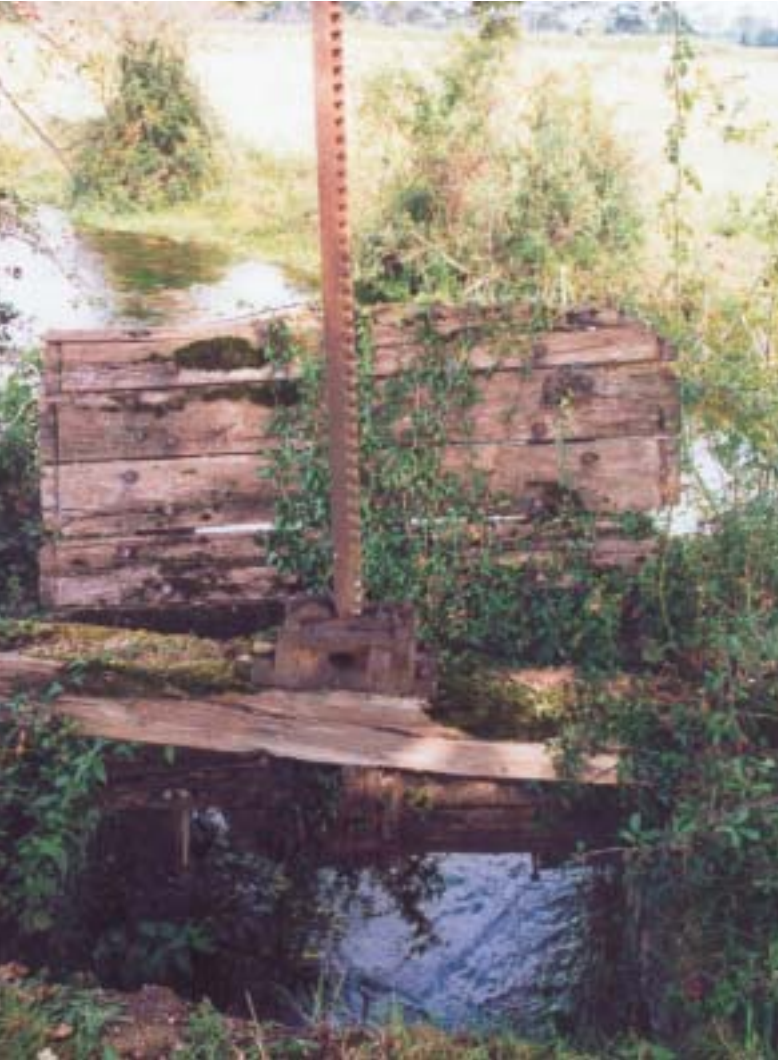
This sluice structure on the River Avon has deteriorated badly. Further delay of the horizontal timber support will result in loss of the cast iron lifting mechanism into the water.

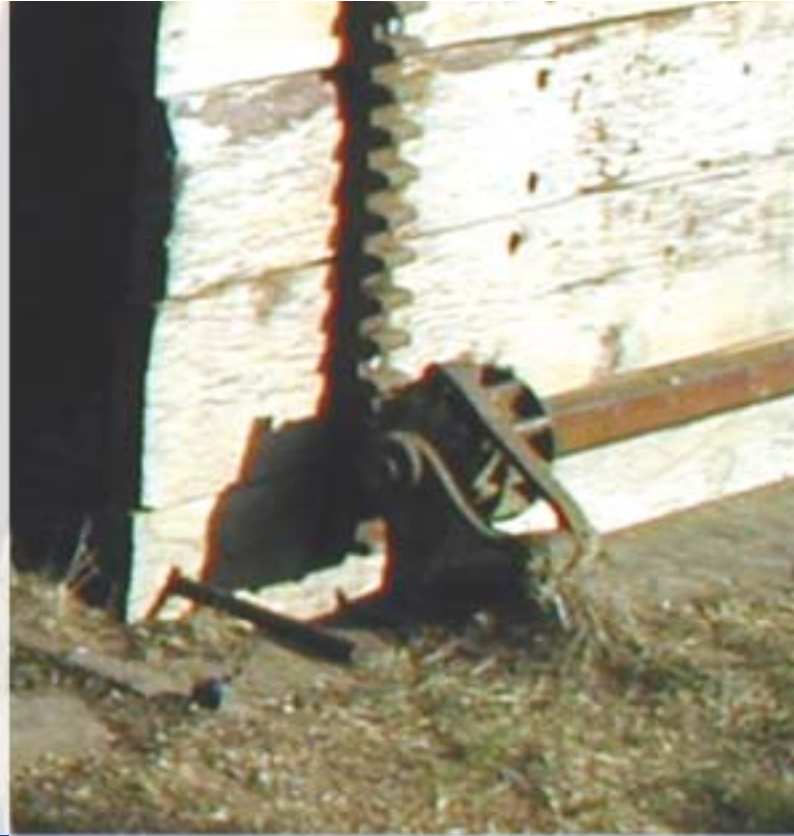
In such a situation, after recording, the structure should be carefully dismantled and stored. Timber sections which are sound should be retained. The replacement of the timber components is relatively straightforward but the cast iron components are both difficult and costly to replace.
