Our Ref: JSL2082-L-01

Date: 22nd November 2012

Re: Oakridge House, Jefferson Road, Basingstoke – Daytime Bat Survey

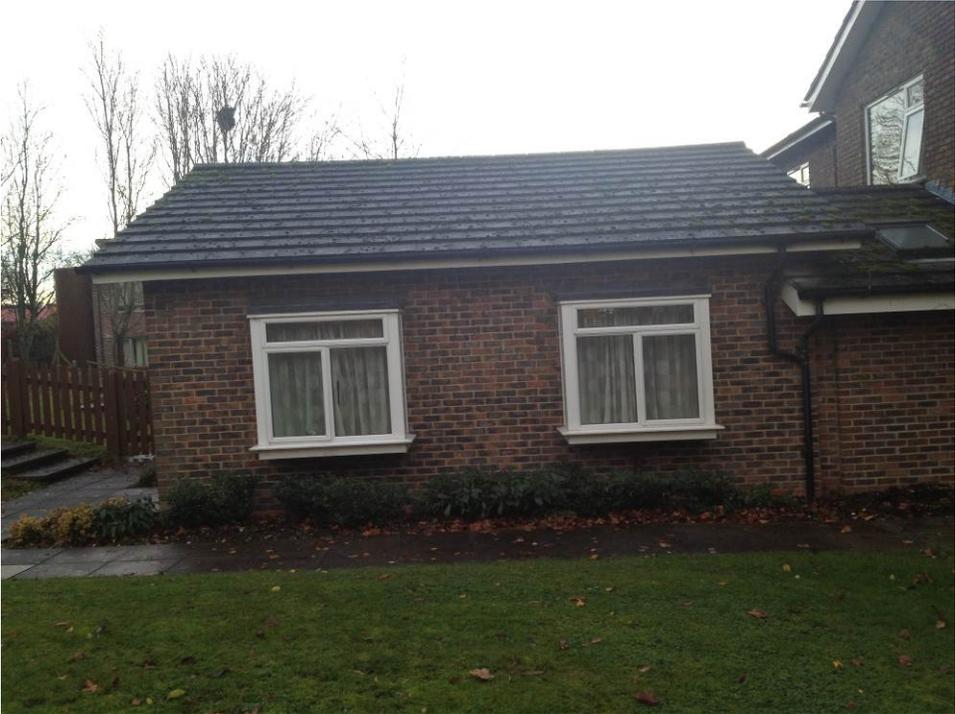
The single storey extension is used as a lounge for the nursing home residents. It measures approximately 36 metres squared and has a pitched roof that is clad in non-traditional concrete tiles. The north-eastern elevation of the building is shown in Photograph 1.

Photograph 1: Single storey extension north-eastern elevation.

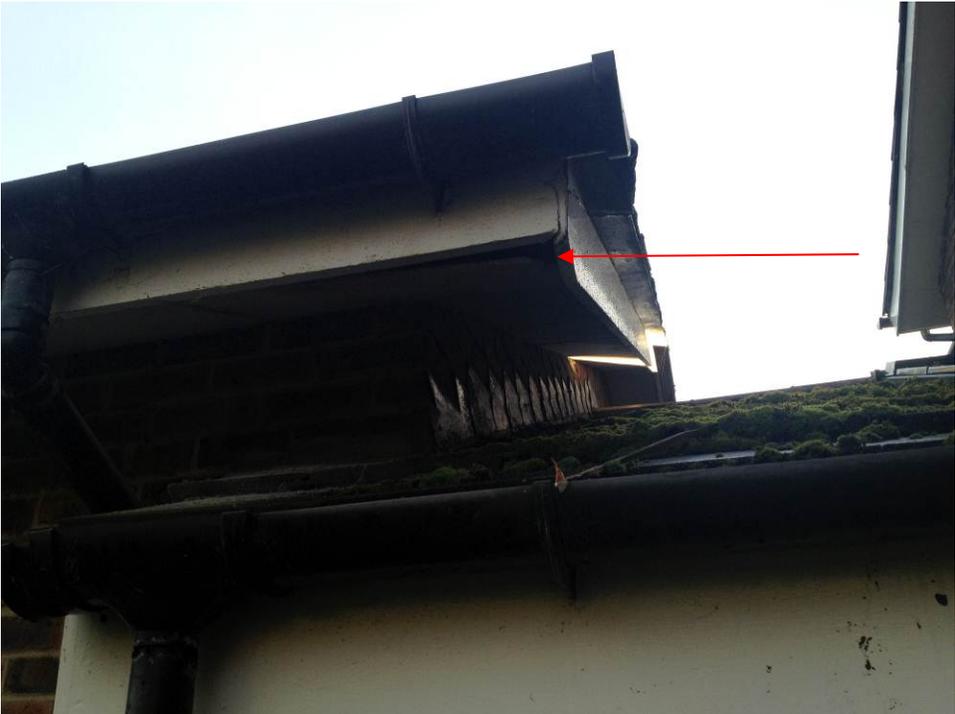
These cavities, shown in Photograph 2 and Photograph 3 were examined with the endoscope and no evidence of bats was found to be present.

Cavity 1, shown in Photograph 2, on the north-eastern elevation comprised of a large gap in the soffit board that had cobwebs present at the entrance to the cavity, implying a lack of bat activity. No evidence of bats or bat droppings was observed internally.

Photograph 2: Potential roosting cavity 1 (indicated by red arrow).

Although no evidence of roosting bats was found, as a precautionary measure, it is recommended that the cracked tiles and the soffit boards are removed by hand prior to the demolition of the building. In the unlikely event that a bat is found during this, all works must stop and the bat left undisturbed and Natural England consulted for advice on further action.

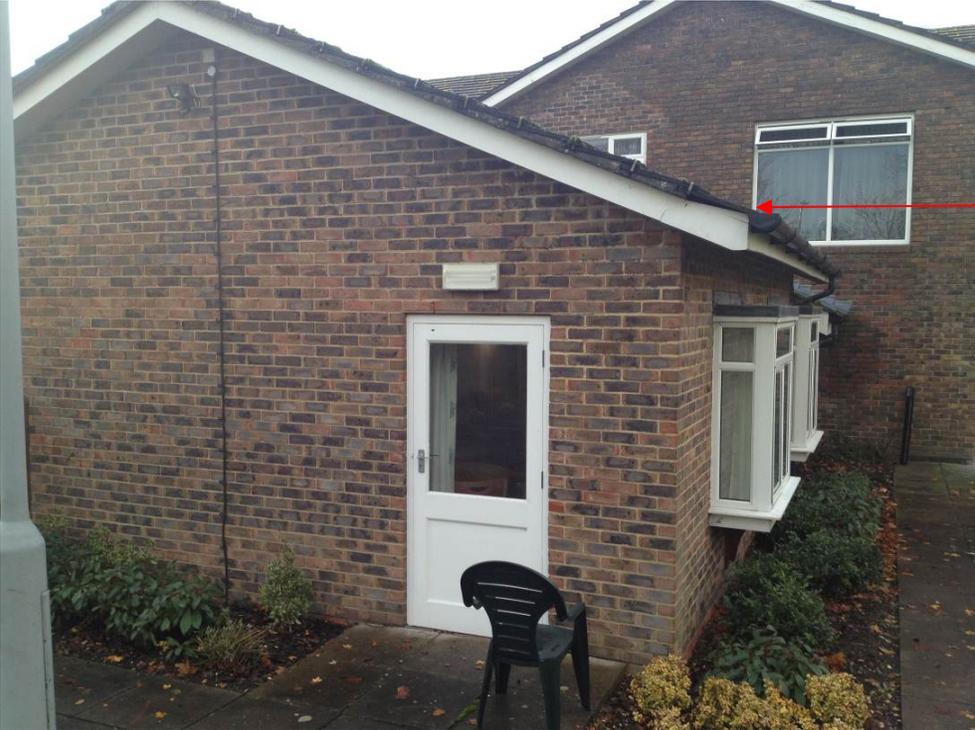
Cavity 2, shown in Photograph 3, on the south-eastern corner of the building comprised of a gap between the soffit board and the roof tiles. This gap did not lead into a space suitable to support roosting bats.

Photograph 3: Potential roosting cavity 2 (indicated by red arrow).
